ASN 28571 (0412)

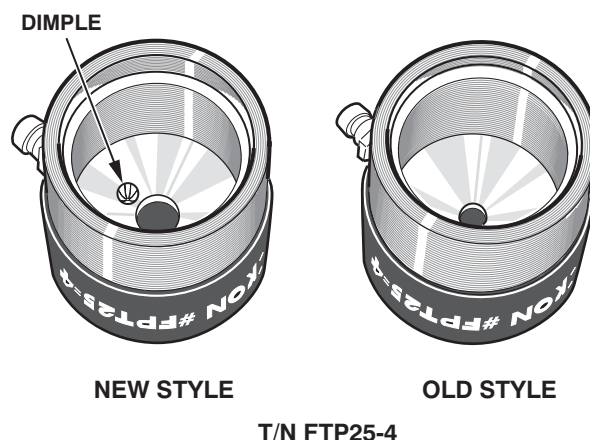
If the smog check station is using a Waekon fuel cap adapter kit, they might not have the right adapter for testing the three-click-type fuel fill caps found on newer Honda models. These caps need a special adapter to test properly; otherwise, they'll flunk the test. This adapter (T/N FPT25-4) has a black cap and a dimple in the bottom. If your dealership is a state-certified smog check station, and you're *not* using this adapter, make sure you order one from Waekon at [www.waekon.com](http://www.waekon.com). (On the home page, click on **Quick-n-EZ parts**. Enter **FPT25-4** in the **quick search:** box, and click on **GO**.) This new adapter supersedes the original part.

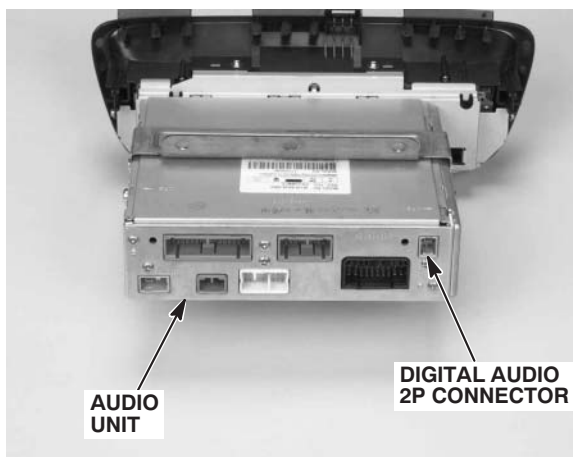
In a '05 Odyssey EX-L or Touring model, if the digital audio 2P connector from the DVD player unit to the audio unit is loose, or it has an open or a short, you'll wind up with this situation:

- You can't hear any DVD sound through the wireless headphones, yet it comes out through the speakers OK.
- You can hear the radio through the wireless headphones.
- The RES display works normally.

To fix this problem, make any needed repairs, and make sure the connector is properly plugged into the audio unit.

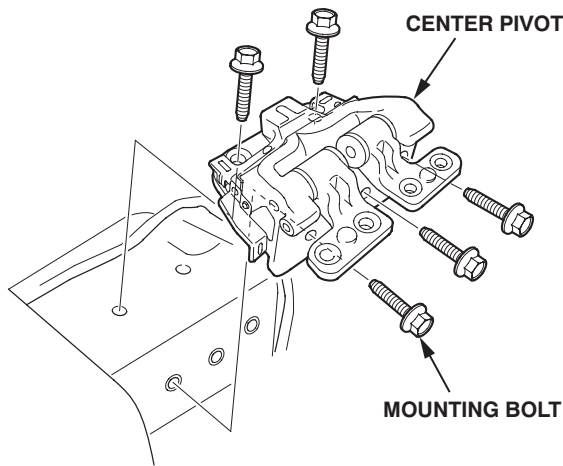
Some '05 Odysseys (from VIN 5FNRL....5B000001 thru 5FNRL....5B018584) may have unsightly surface rust on the third seat center pivot. If you get one of these in your shop, here's what you need to do:

1. Remove both third row seats (see page 20-186 of the 2005 Odyssey S/M). (On ISIS, enter the keyword **PIVOT**, and select **Third Row Seat Pivot Removal/Installation** from the list.)

NOTE: To remove the third row seat, you must use the stopper plate (T/N 82217-SHJ-A01) called out in step 11 of the S/M. It keeps the spring in the pivot from unwinding. This required special tool belongs in drawer #15 of the Body 1 tool storage cabinet.

2. Remove the third row seat center pivot (five bolts).
3. Use steel wool to remove any rust that's formed on the pivot surface.
4. Mask off the bolt holes and the bushing area on the center pivot, then apply a coat of spray paint. Make sure you spray the paint in a safe area away from the vehicle.
5. Reinstall the center pivot. Torque the bolts to **54 N·m (40 lb-ft)**.
6. Reinstall the third row seats.
